**The MacFarlan House:
A Survey of an Okie-Designed Work in Progress**

Rebecca Angeline Geist

Historic Preservation

1998

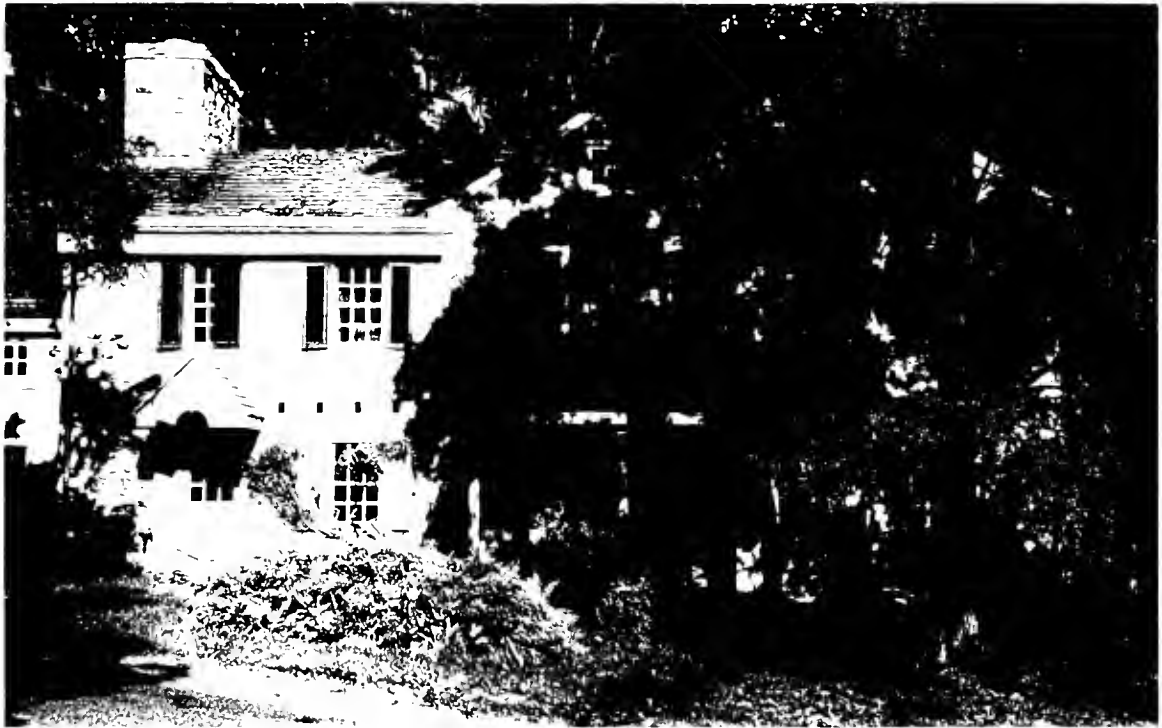
Figure 3.23b Exterior, West Elevation The dining room ceiling joists protrude through the stone wall and can be seen above the window.

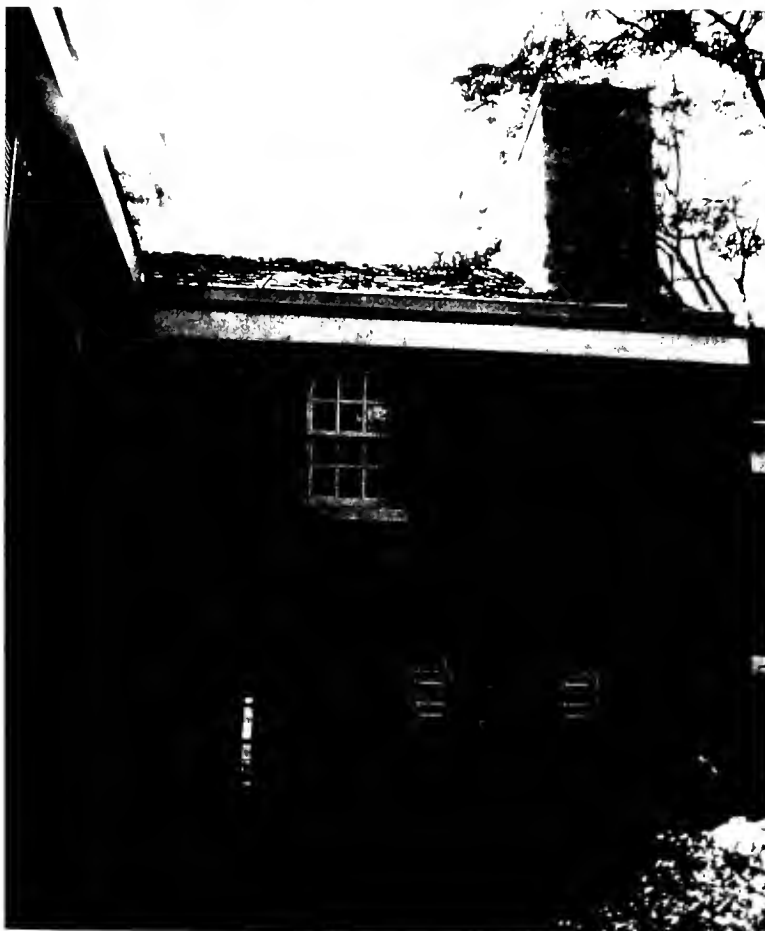
Figure 3.23c Exterior, East Elevation The dining room ceiling joists can be seen protruding through the stone wall. Notice the larger one corresponds precisely with the reflected ceiling plan.

²¹ Of interesting note: The North farm house incorporates an historic addition which employs this characteristic of protruding joists through the stone wall as seen in and may have been a source of idea for Okie's design.

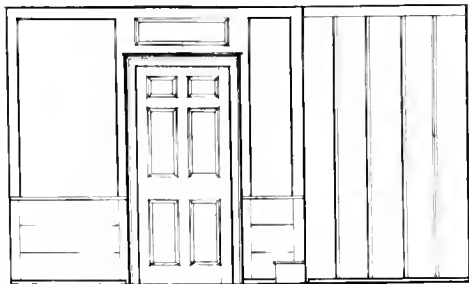
Figure 3.25a Library, West Elevation This wall incorporates random width feather board horizontal beaded board and horizontal beaded board wainscoting with plaster above. The door to the living room is recessed with the side jambs paneled.

R. Brognard Okie incorporated historic details which existed when he began his design for Colonel MacFarlan in what was to become the library (Figs. 3.25a-3.25d). Okie's floor plans and the details from the mill indicate the location of the door to the staircase was to be retained along with the mantel over the fireplace. Okie designed this room with the typical horizontal beaded board wainscoting with plaster above for the south and east walls, while incorporating a combination of the horizontal wainscoting, feather board and plaster along the west wall. The north wall is feather board across (like that of the living and dining rooms). The chair rail and base board are all similar to those used in the dining room and throughout the house. The radiator grills for this room were designed to blend with the wainscoting, incorporating the characteristic horizontal beaded board motif with a front grill and a solid window sill.

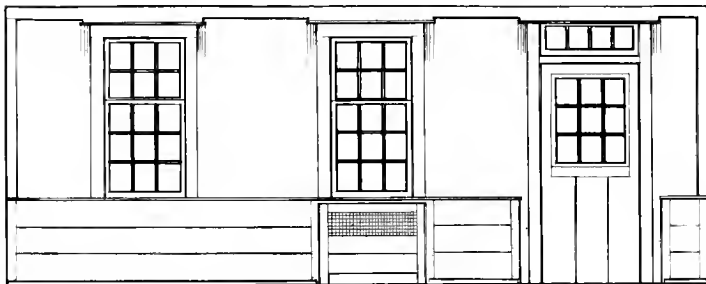
Figure 3.25c Library, South Elevation This wall contains two windows, one with a radiator below, the other without. The door on the right leads to the front terrace. There is a four-light transom above. The plaster, not including the baseboard, curves around to meet the door trim.

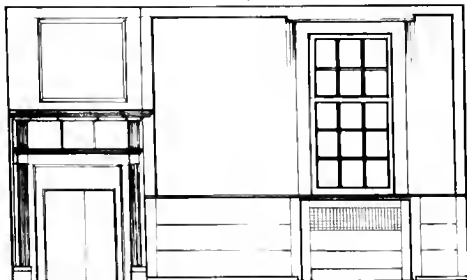
Figure 3.25b Library, East Elevation This elevation includes the historic mantel Okie chose to reuse with an Okie-designed single raised panel above. The remainder of the wall is horizontal beaded board wainscoting (typical throughout the MacFarlan house) with plaster above.

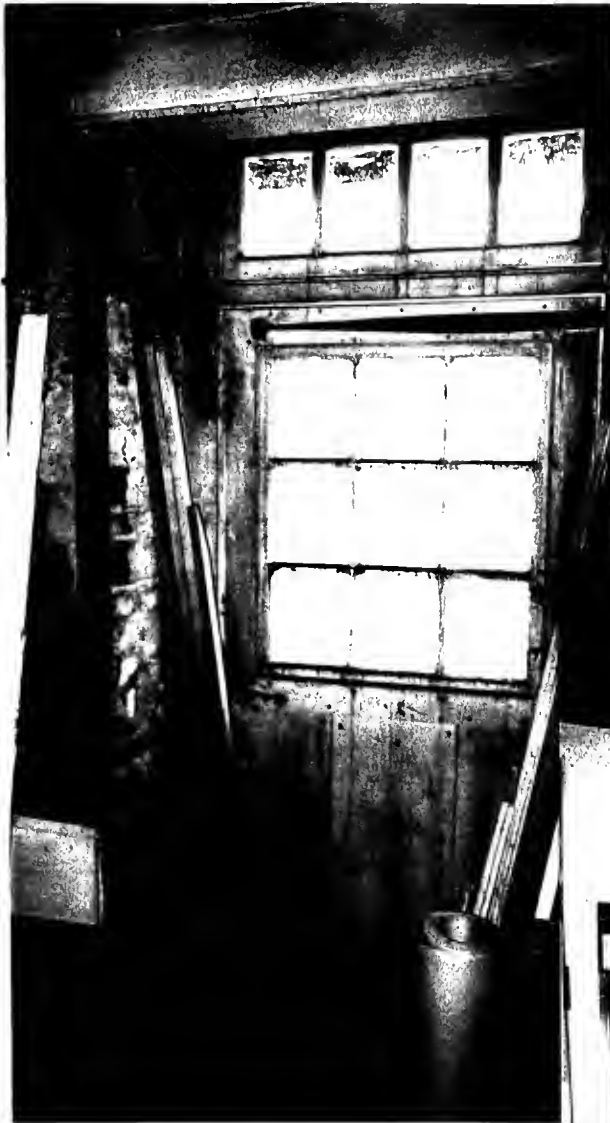
Figure 3.28a The door into the living room was designed to have a rounded plaster jamb, but was constructed as having the jamb at a right angle and paneled. A raised panel was also added over the door.

placement of a wooden header above the door to the terrace. Originally this was not in the drawings. Because this section was constructed with the header here, it has a very dissatisfactory meeting with the transom window above the door (Fig. 3.28b). The second variance from the plans is the treatment of the passage and door into the living room. This was indicated to have been designed with a rounded plaster jamb to the door trim and was actually built squared and paneled to the door with a raised panel header above (Fig. 3.28a).

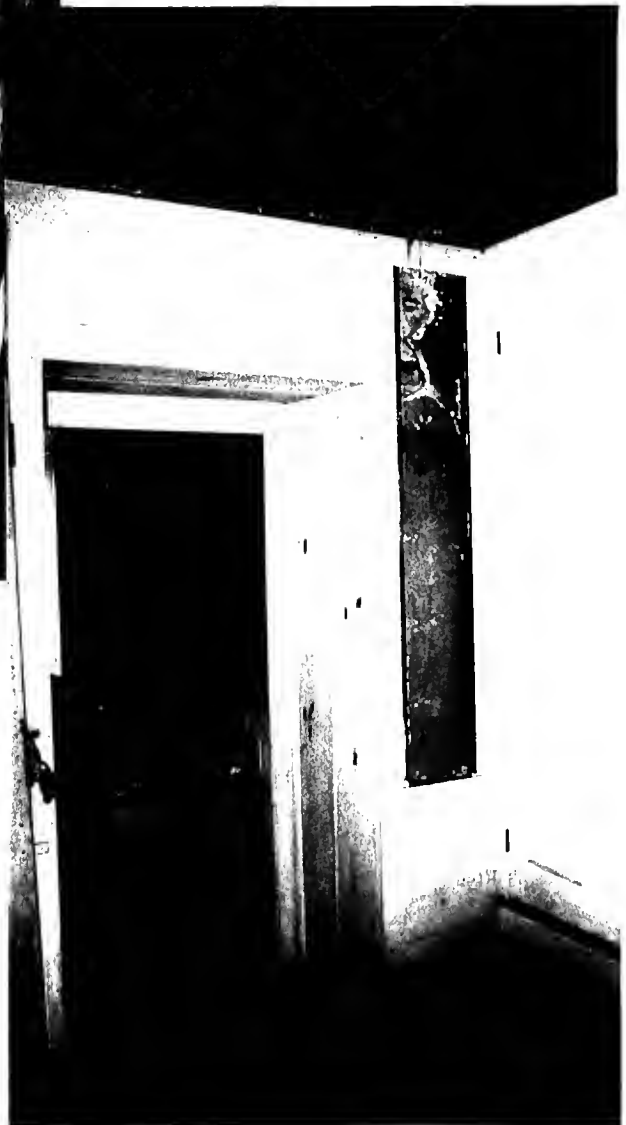
Figure 3.28b Though it is difficult to understand with the photograph angle, the header constructed over the door does not correspond with the transom window. The bottom of the header barely clears the top of the glass.

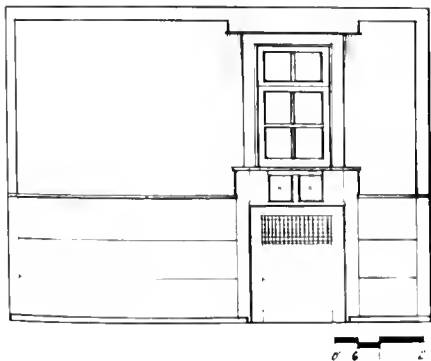
Figure 3.20b This elevation is of typical horizontal beaded board wainscoting which is mortised, tenoned and pegged into the surrounding studs with plaster walls above. A unique built-in with two drawers and a radiator grill cover are tucked underneath the unique two over four window.

Figure 3.20c This is a larger detail of the built-in under the window sill to show the separate pieces of millwork used (drawings surveyed and adapted from Okie prints).

A large detail was drawn to depict the different pieces of millwork incorporated in the construction of the built-in. All millwork is 13/16" thick. The radiator grill cover blends with the beaded board wainscoting and is removable. The two drawers are handsomely crafted with dovetail joints and wooden drawer pulls as shown in Figures 3.30a-3.30b.

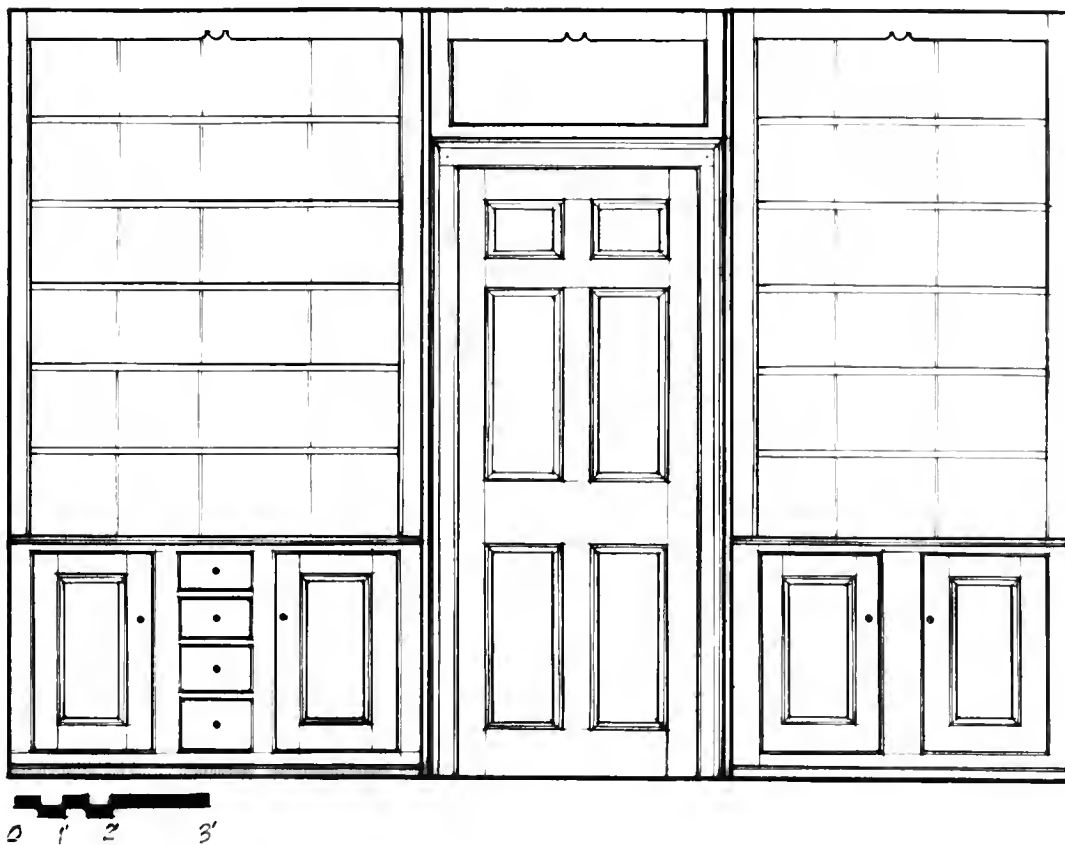
Figure 3.32a Study, West Elevation The bookcases are explicitly detailed with the characteristic Okie "scallop" appearing at the top of each section.

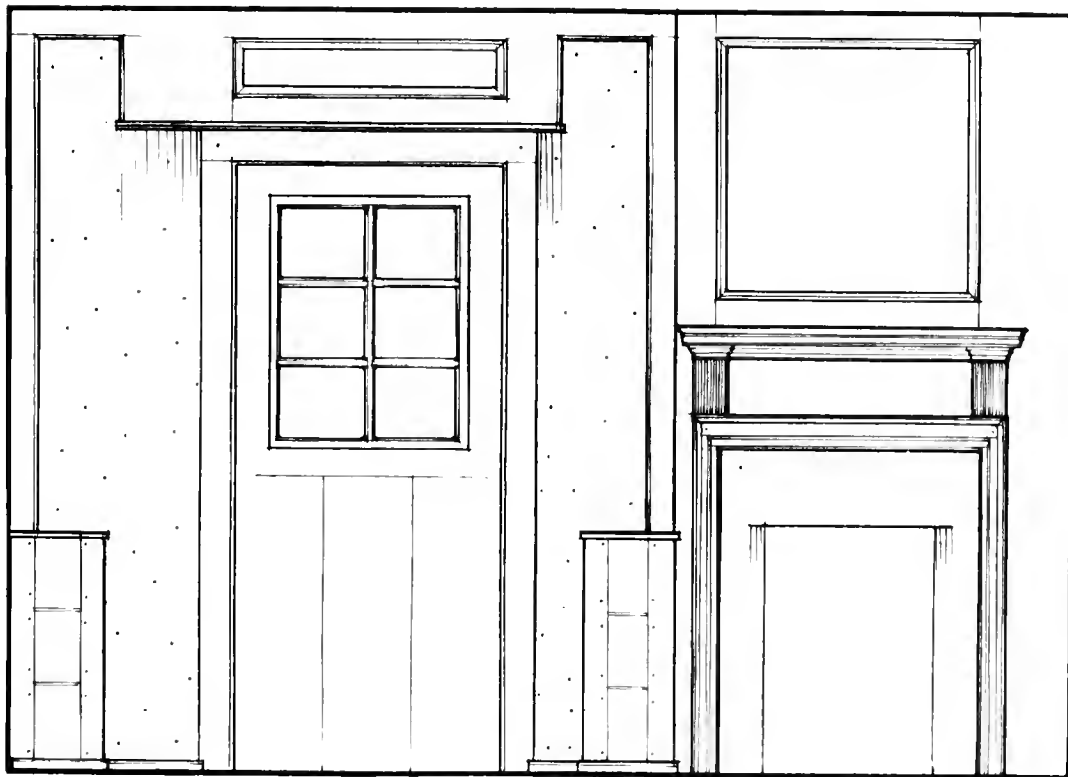
Figure 3.32b Study, East Elevation This wall incorporates a door to the east porch. The plaster curves around the thick stone walls to meet the door trim, as does the base board. The fireplace is at a 45 ° angle between the south and east walls and has an Okie-designed mantel with a single raised panel above (Drawings surveyed and adapted from Okie prints).

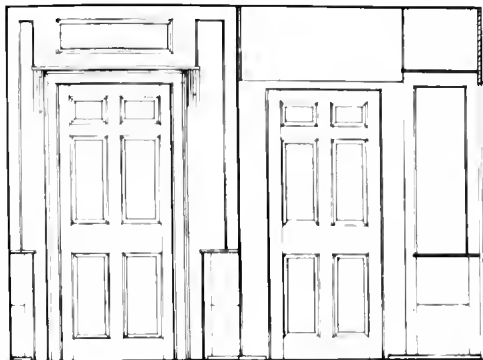
Figure 3.36a East Hall, South Elevation This wall is two distinct levels. The one further back is the door into the library. Here, the plaster curves to meet the door panel, but the backboard does not. The section further up is the door to the basement and the adjacent wall. This wall is very complicated due to the sloping ceiling above.

The south wall has the door into the library. This door is treated in a similar manner to other doors where the wainscoting and baseboard were stopped before the curve begins, plaster then reaches the floorboards and wraps around the curve to meet the door trim. This detail can be seen finished in R. Brognard Okie's own house in Figure 3.38. Because the stair to the second floor is above this hall, the ceiling angles with them above the entrance to the basement stairs. This makes for a very complicated plaster finish and is best shown in the drawings. The west wall is the typical horizontal beaded board and plastered above across the wall to the basement stairs, while there is an arched passage into the west hall.

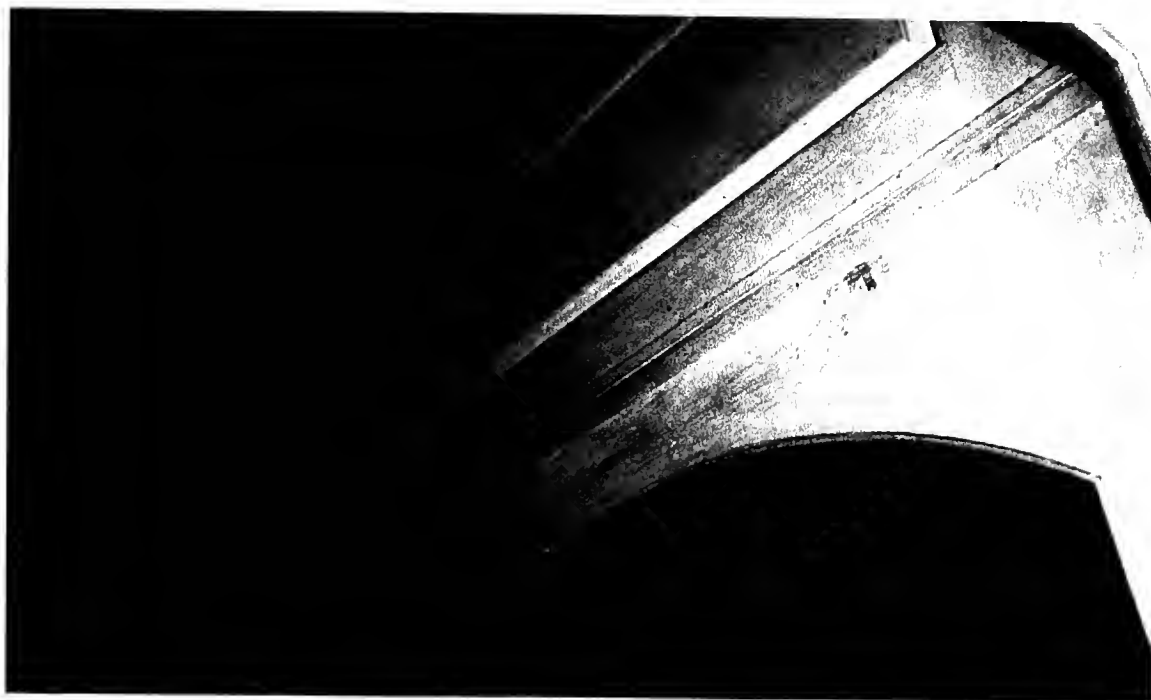
Figure 3.37b This photograph shows how the wall was thickened to create enough room for two panels (one facing into the east hall and the other to the rear as seen in the photograph. A small piece of trim was added to cover the seam).

The East Hall (leading into the lavatory, study, dining room, basement and west hall) is a unique room in the MacFarlan house employing four unique wall elevations (Figs. 3.36a-3.36d). The east wall is of random width feather board as is the north wall. A curved passage is built into the north wall leading into a smaller area where the door to the lavatory and the door to the outside are located. Above this door is a small raised panel, similar to those previously described; however, this panel differs from others because it is to be seen from not only this side, but from the opposing side as well. The reverse side of this panel shows that the feather board wall was too thick and another layer of identical board was placed on the opposing side to fit a similar panel (Fig. 3.37a and 3.37b). A small piece of trim was added to this underside to hide the seam. Now this paneled area is two boards thick.

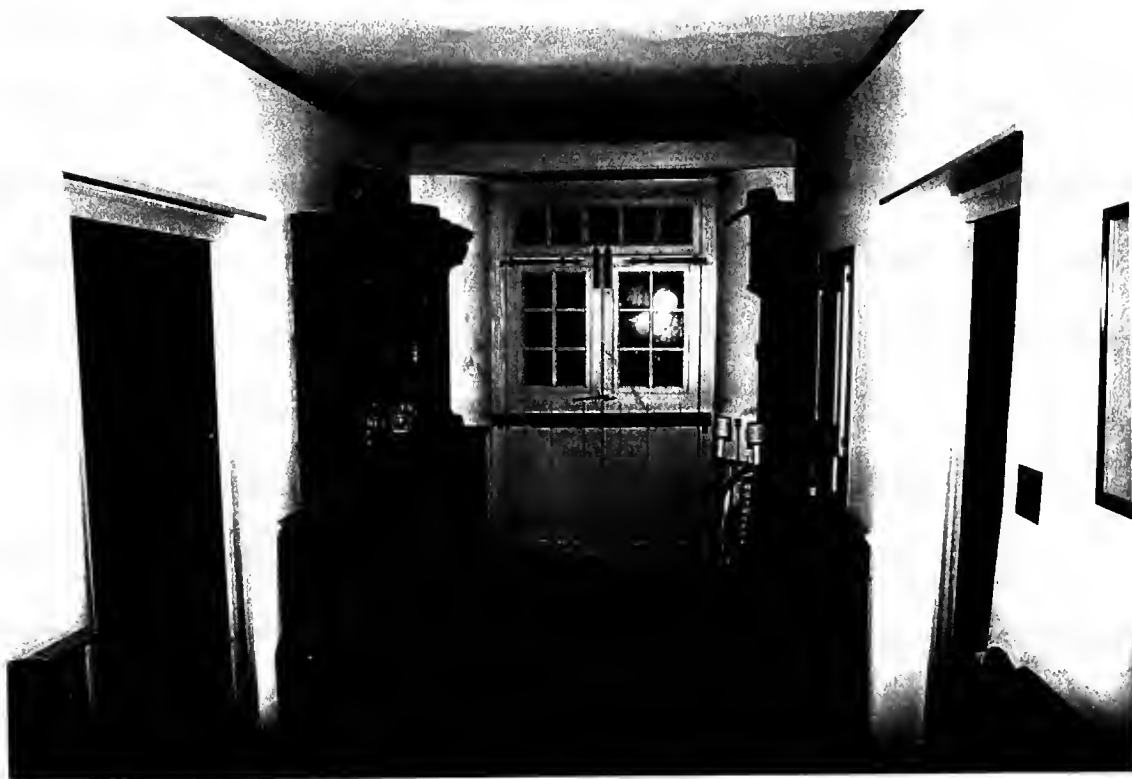
Figure 3.38 R. Brognard Okie's own house, Hillside Farm, incorporates the typical curved plaster jambs all the way to the floor without the baseboard as shown on both sides of the entrance hall (Courtesy of James B. Garrison).

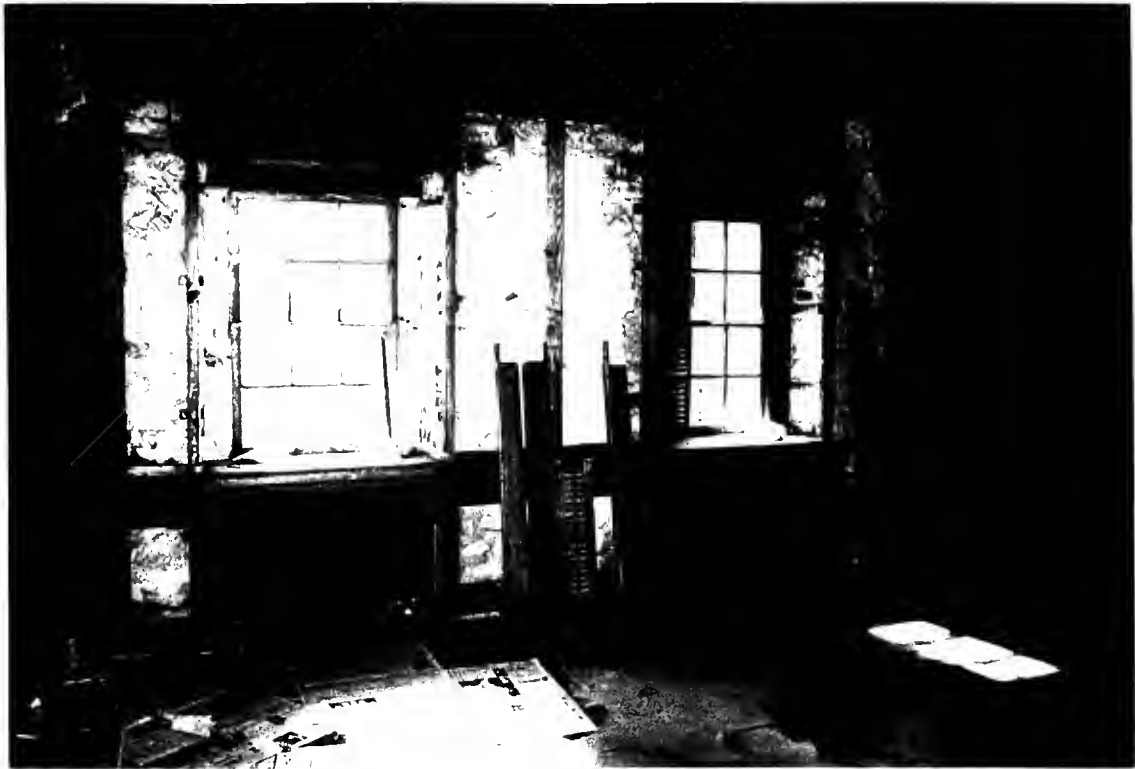
Figure 3.40a Master Bedroom (Bedroom D), West Elevation The wood for this room is a natural finish cherry. Notice the 12" chair rail running across the wall. This detail is unique to the interior of the MacFarlan house, though used on the exterior porches. The top and bottom of the chair rail is profiled to receive plaster. One radiator is placed under the south window, while the north window void was designed for a small cabinet.

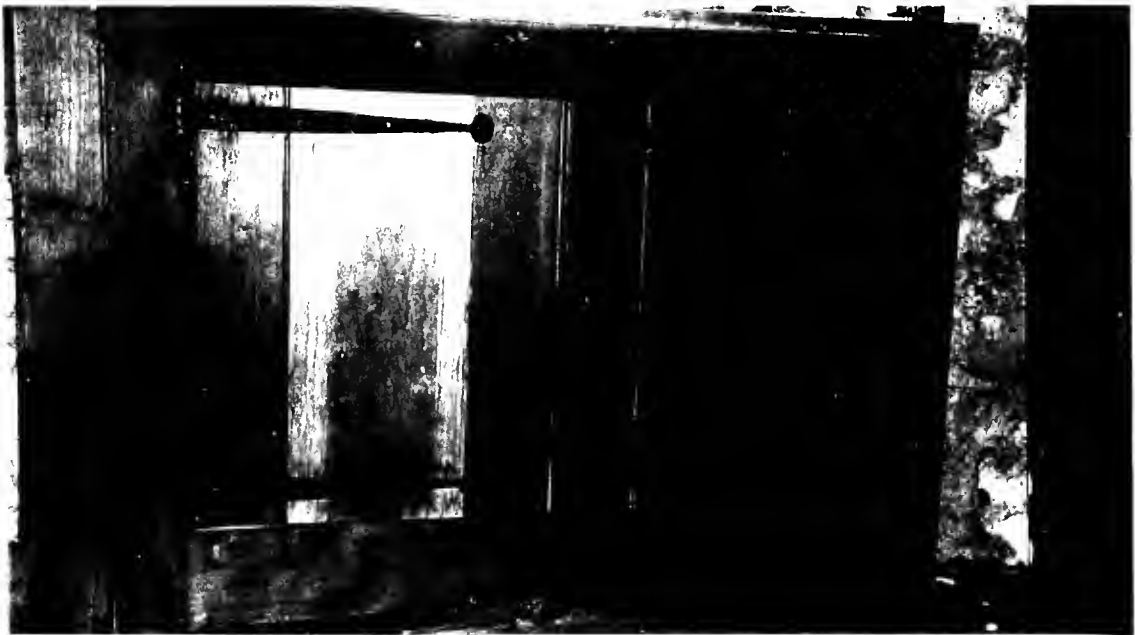
Figure 3.40b Master Bedroom (Bedroom D) A small cabinet is inserted in the void below the window sill of the west wall. The small cabinet has a beaded board front and is held by small strap hinges on pintles. Upon examination of the interior of the cabinet it becomes apparent it is held together by screws, though the beaded boards are tongued and grooved.

This is the only room of the house where a 12" chair rail, beaded and profiled to receive plaster on both the top and the bottom, is used on both the east and west walls (Fig. 3.40a). The south wall is cherry random width feather board. The fireplace wall is a random width beaded board paneling, containing a raised panel closet door, a small cabinet door, and a door to the master bathroom and closets. The mantel is incomplete and the design is unknown. The west wall incorporates one radiator under the south window, while a small random width, beaded board, two-door cabinet lies under the north window (Fig. 3.40b). This small doors are held in place by small strap hinges and opens with a small wooden knob.

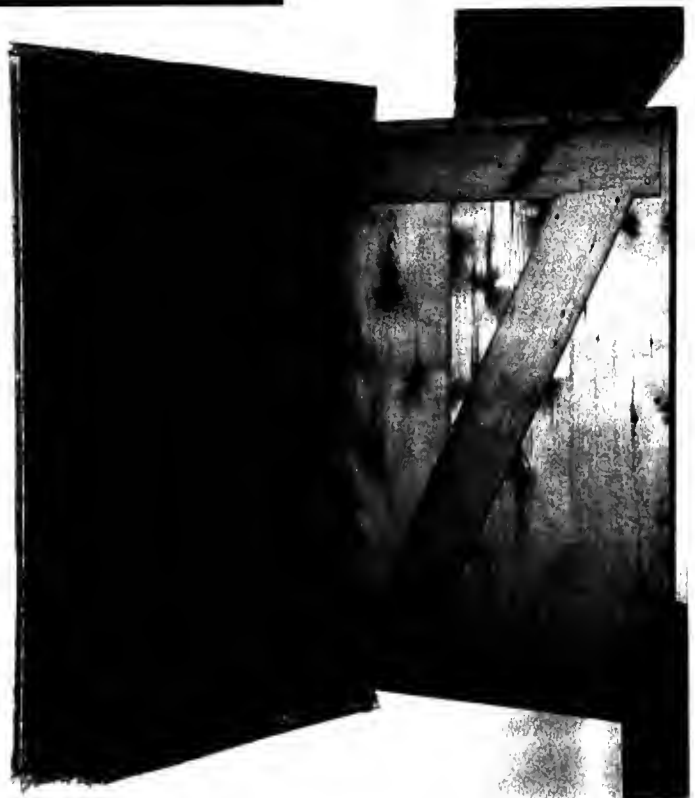
Figure 3.41b and 3.41c **Servant's Quarters, West Wall** The cabinet lies to the right of the previously mentioned cabinets. This door leads to a large storage space under the eaves of the rear porch. It appears the jamb is made of recycled wood, as paint remnants and the inconsistency of a small head running across the top and not meeting a bead to the sides. The threshold of this cabinet is a large, flat stone.

The Servant's Room does contain ample storage space along the east wall (Fig. 3.41a). The southern-most cabinet is very unique in that it rests on a stone base and its jamb appears to have been constructed of antique beaded lumber (Figs. 3.41b and 3.41c). The newel post for the small staircase is beaded within inches of its top, similar to those designed for the front terrace, only on a smaller scale. Both windows in the room have plaster surrounds and hide small radiators underneath. The ceiling joist in this room stretch across from east to west and are pegged into the rafters which are exposed along the west wall (Fig. 3.41e).

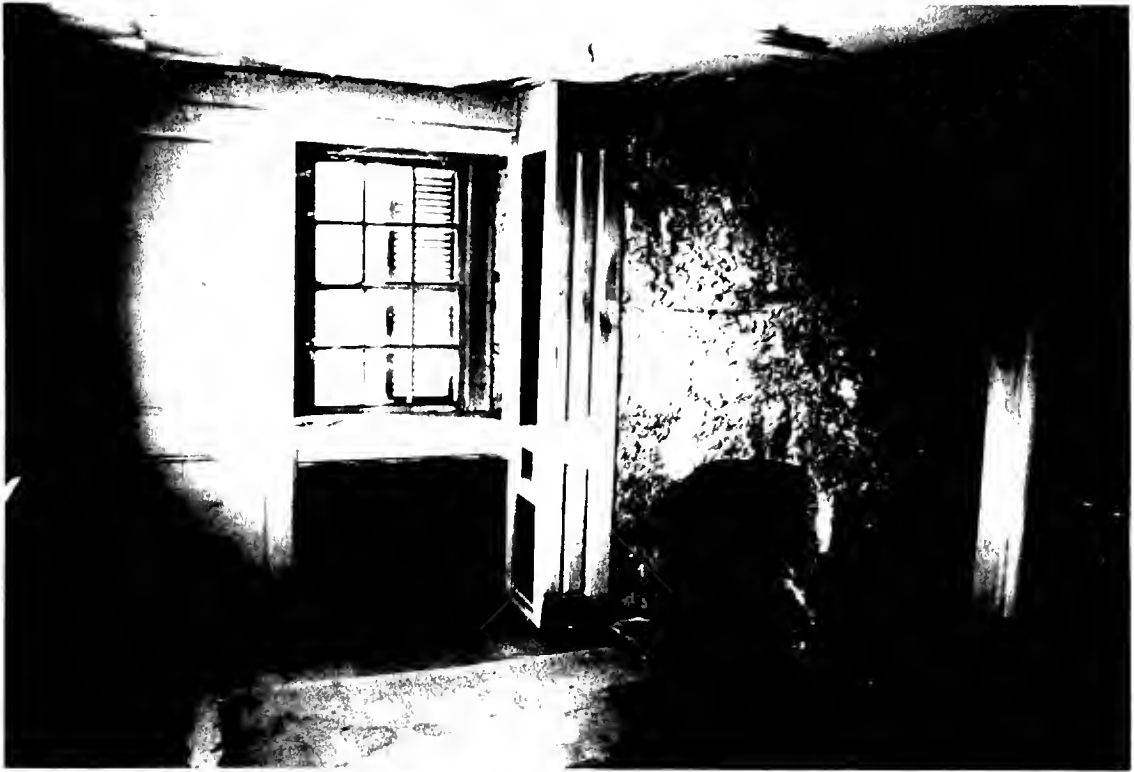
Figure 3.42a Bedroom A, West Elevation The west wall of this bedroom underwent many changes to the area left of the fireplace. A small gun cabinet with a drawer was constructed and never completed.

The Southwest Bedroom (Bedroom A) was only partially completed. The drawings for the room originally showed the fireplace wall as being arranged differently than it was built. The as-built condition of the west fireplace wall exists of a raised panel elevation with no chair rail (the only such wall in the MacFarlan house), a radiator under the window and a small gun cabinet (facing south) with raised panels on its side (Fig. 3.42a-3.42b). The actual fireplace area was never constructed, therefore the drawings were relied upon to imagine what the mantel, fireplace surround, and immediate areas were to have appeared (Fig. 3.43a-3.43b). The cornice appears to be similar to the one installed in the living room (below this bedroom). Notice the small scallop detail in the trim above the window. The south and east walls of this room is the typical horizontal beaded board wainscoting with plaster above, while the north wall is random width feather board. The hearth in this room is stone with a curved wood

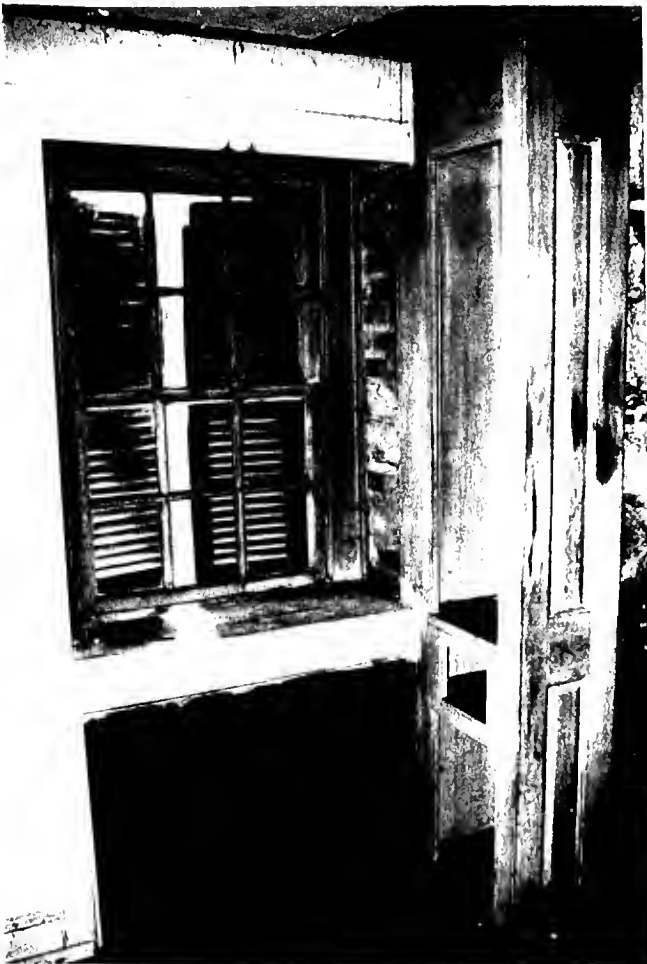
Figure 3.42b Gun cabinet and window. Notice the small scallop detail at the top of the window.

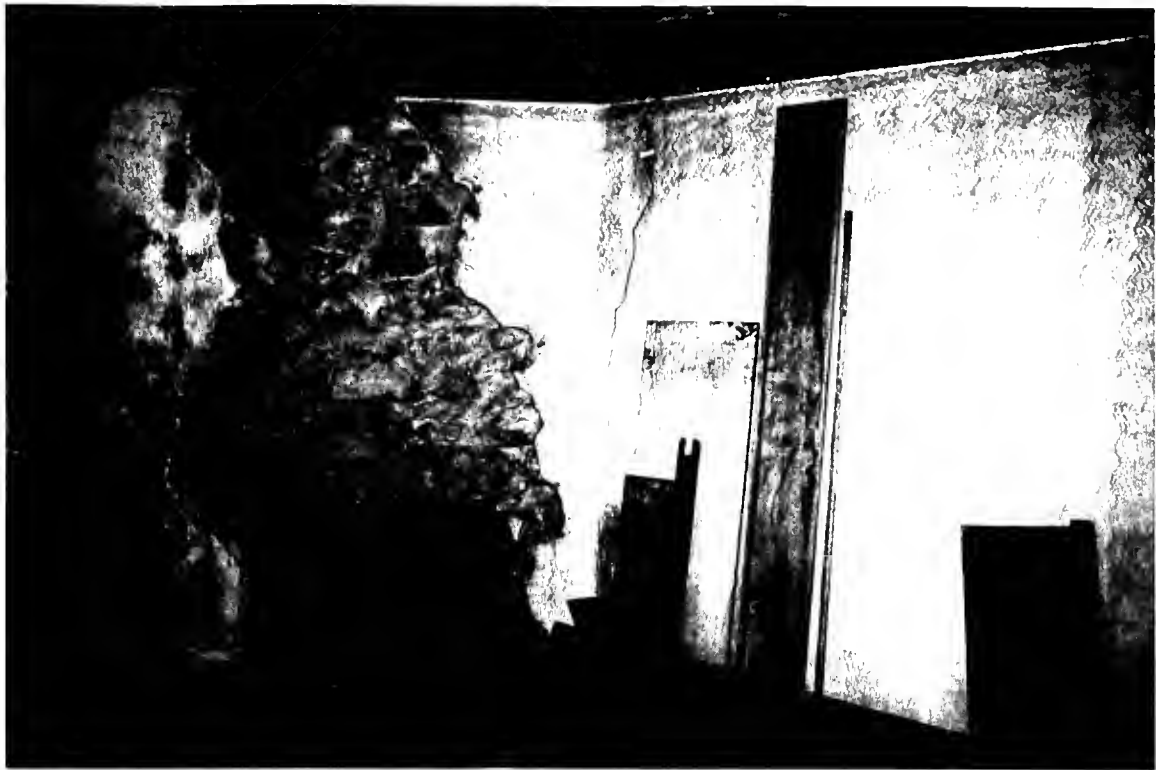
Figure 3.44a Bedroom C, East Wall The wall is at a 45° angle to the south and east walls. Okie added this fireplace, but no drawings or descriptions as to its design have been located.

Though drawings for this room by Okie have never been found, he did add a small fireplace in this room where there was not one before (Fig. 3.44a). The hearth in this room is stone and is semi-circular. The floorboard surround is also curved to match the hearth and individual boards are dove-tailed to one another to form the perimeter (Fig. 3.44b)

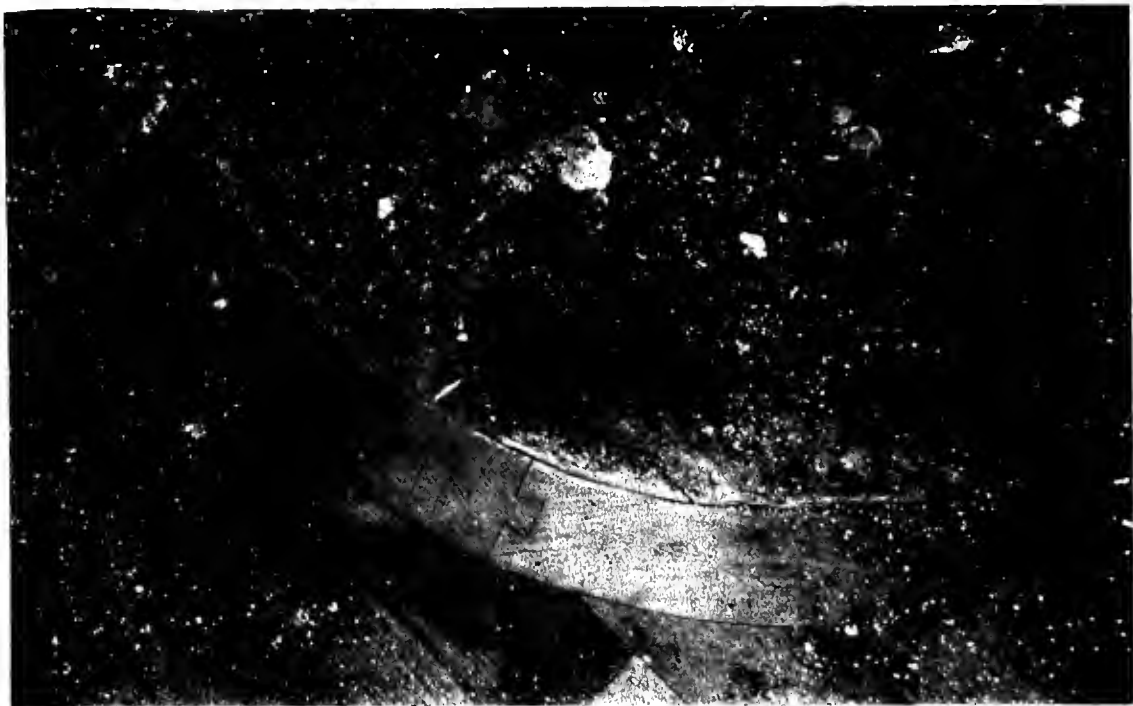
Figure 3.44b The hearth for the fireplace is stone with a semi-circular floorboard surround of which individual pieces are dovetailed to one another.

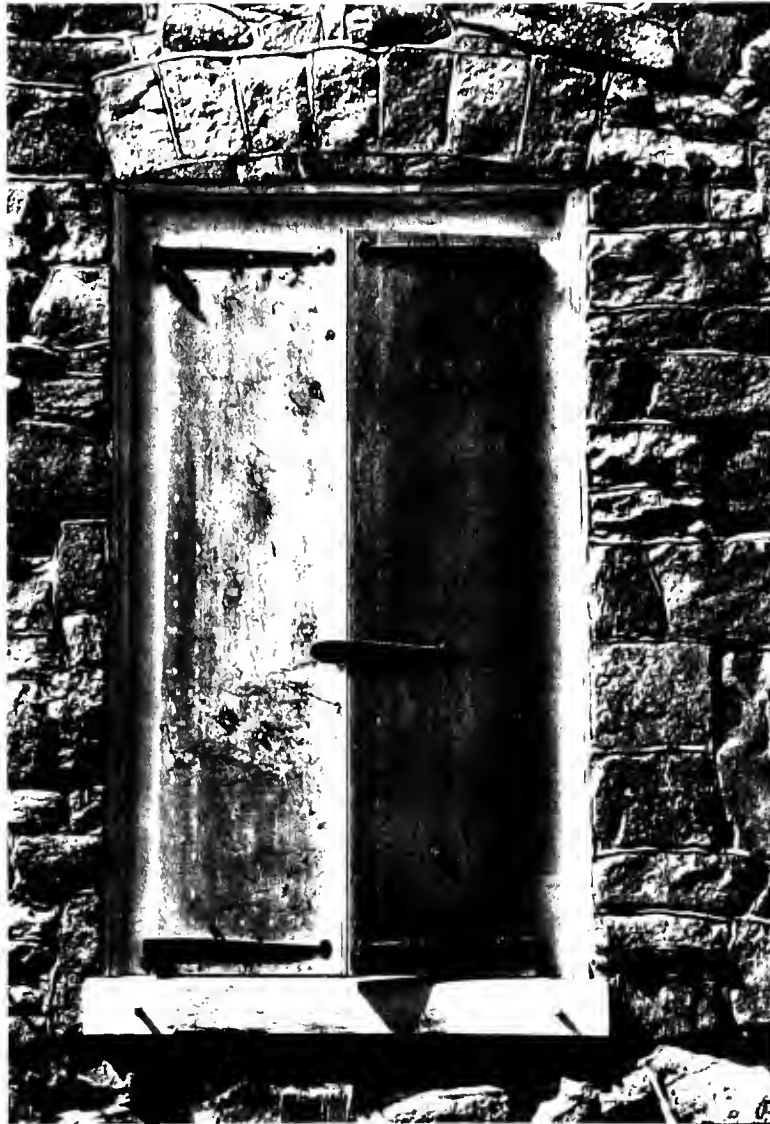
Fig. 4.2 Shutters of the MacFarlan house are hung on re-productions of typical historic Pennsylvania strap-hinges and pintles found throughout the late 17th and 18th Centuries as is the shutter bar lock.

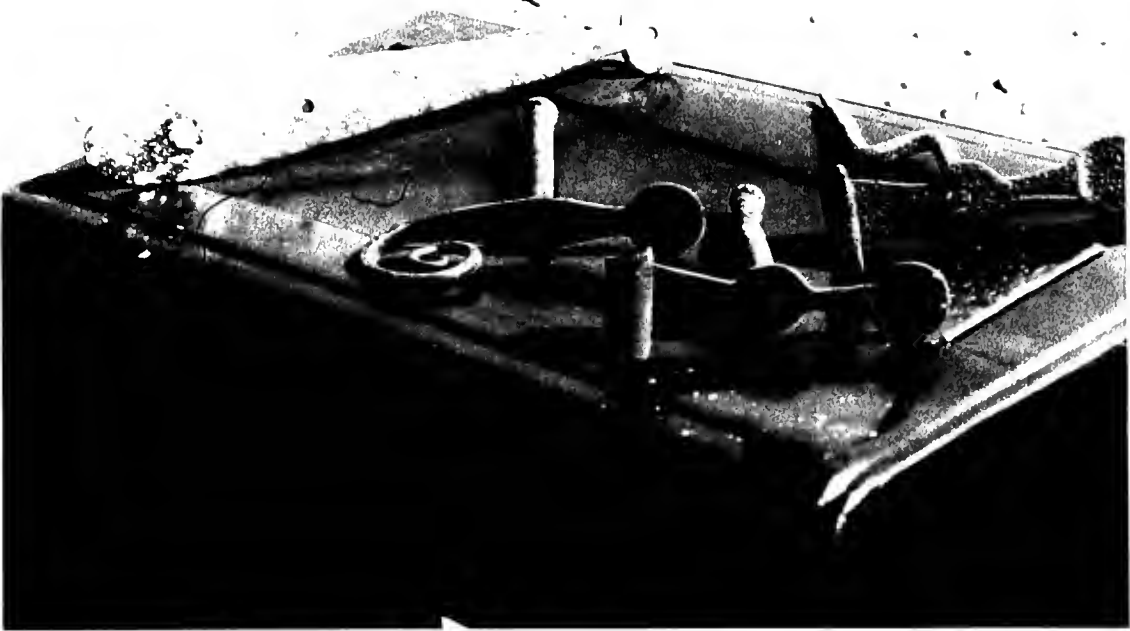
Figure 4.3a This photograph displays the various types of shutter hardware used on the MacFarlan house. (Left to Right) The first piece is the shutter bar lock which fits tightly into a small hole on the opposing shutter; the second is a reproduction "rat tail" shutter fastener (or shutter dog) and is anchored into the stone wall and turns to either release the

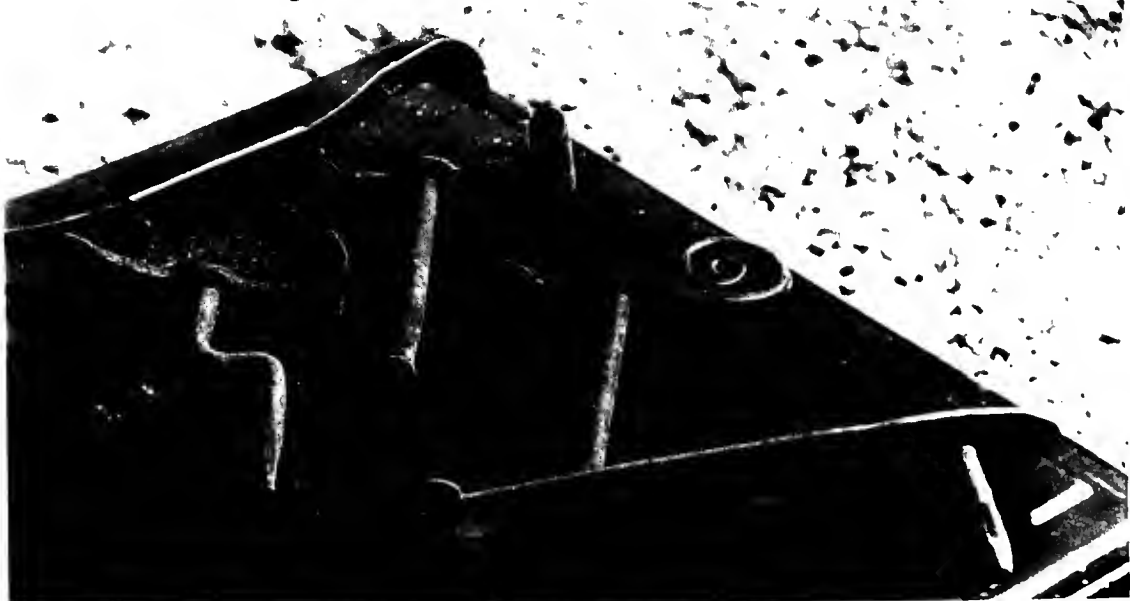
Figure 4.3b This photograph is of the rear of the above shutter hardware. Notice the slot in the shutter bar lock escutcheon. This type of shutter bar was not self-latching and required a small iron key to be inserted through the slot to lock the shutter closed.

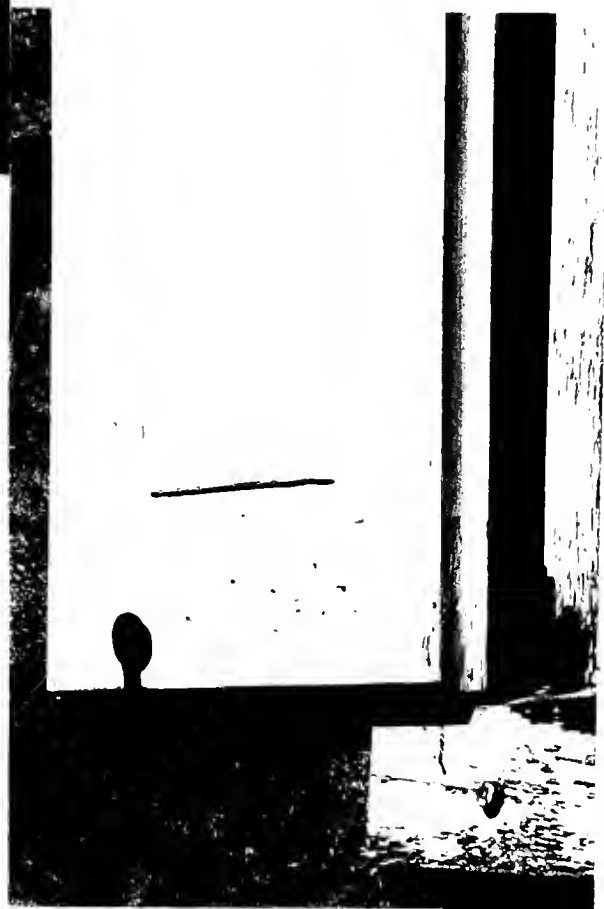
Figures 4.4a and 4.4b

The two variations of shutter fasteners installed on the exterior of the MacFarlan house (the bottom is often referred to as a rat tail fastener).

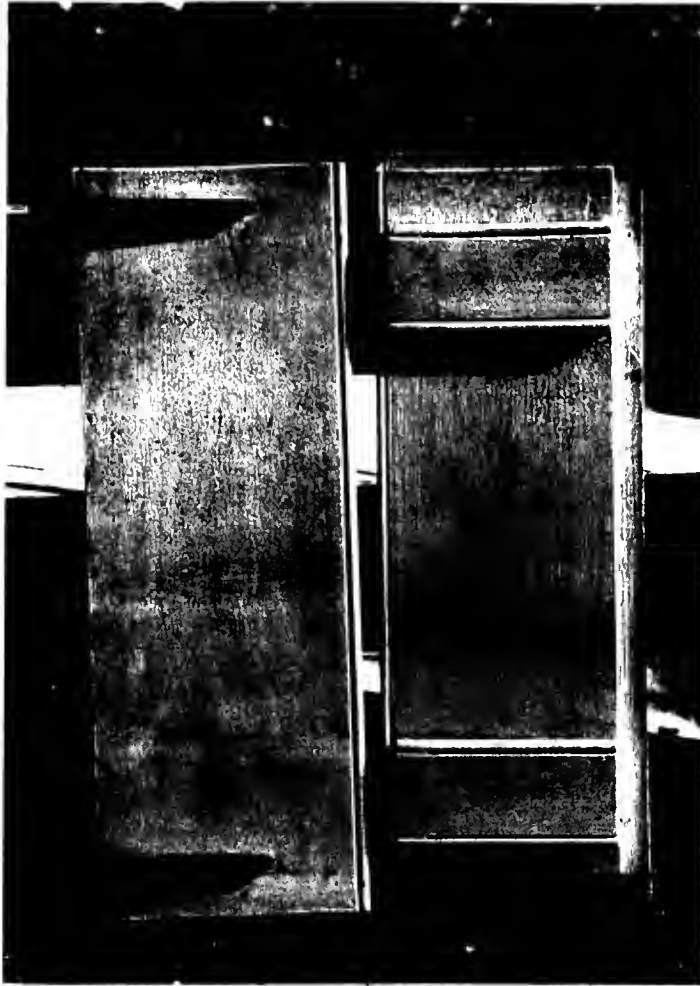
Figure 4.5a Okie designed and installed wooden hardware for the spring house at the tenant house. This photo-graph is of the small shutters (front and back) which are hung by wooden hinges on wooden pintles.

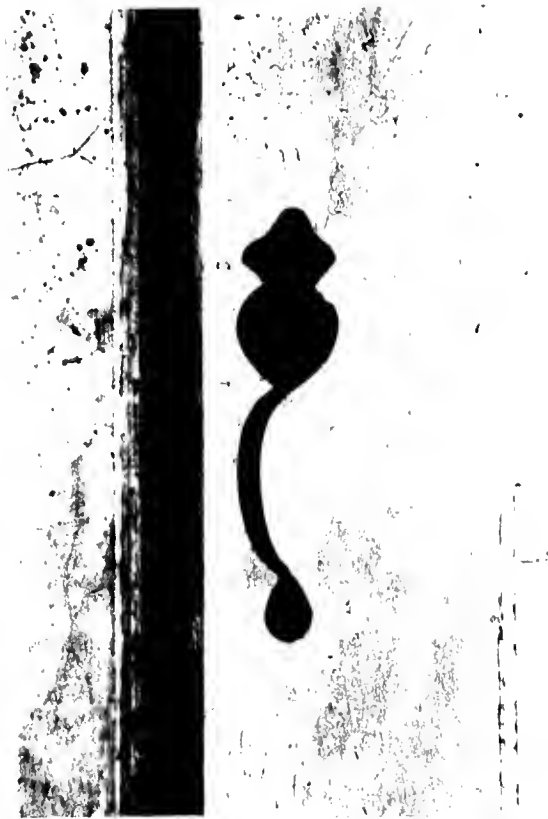
Figure 4.6a This Suffolk latch has a dominant upper cusp, a variation of the common tulip style, with a rounded handle and decorative tooling around its middle.

Figures 4.6a-4.6d These are three distinct types of Suffolk latches installed on the exterior doors of the MacFarlan House

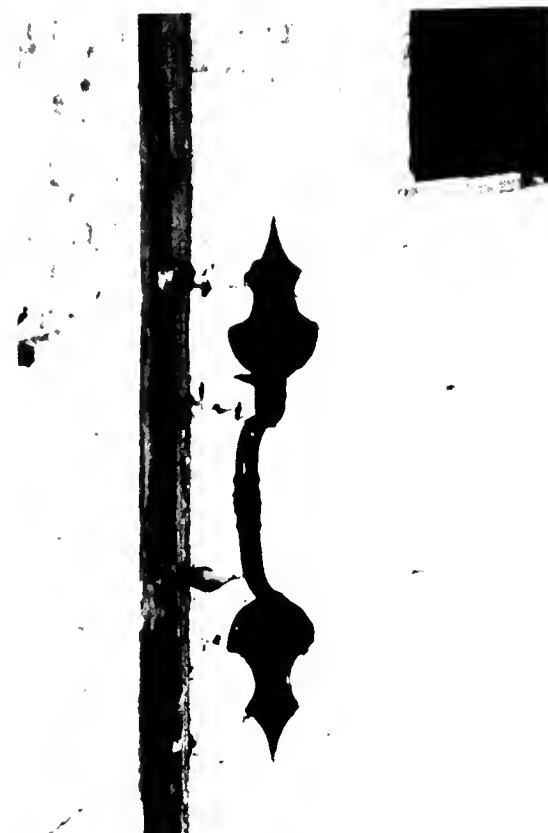
Figure 4.6b This Suffolk latch is an elaborate variation of a combination of a typical spear-head and tulip styles. The handle is rounded with decorative tooling around the middle.

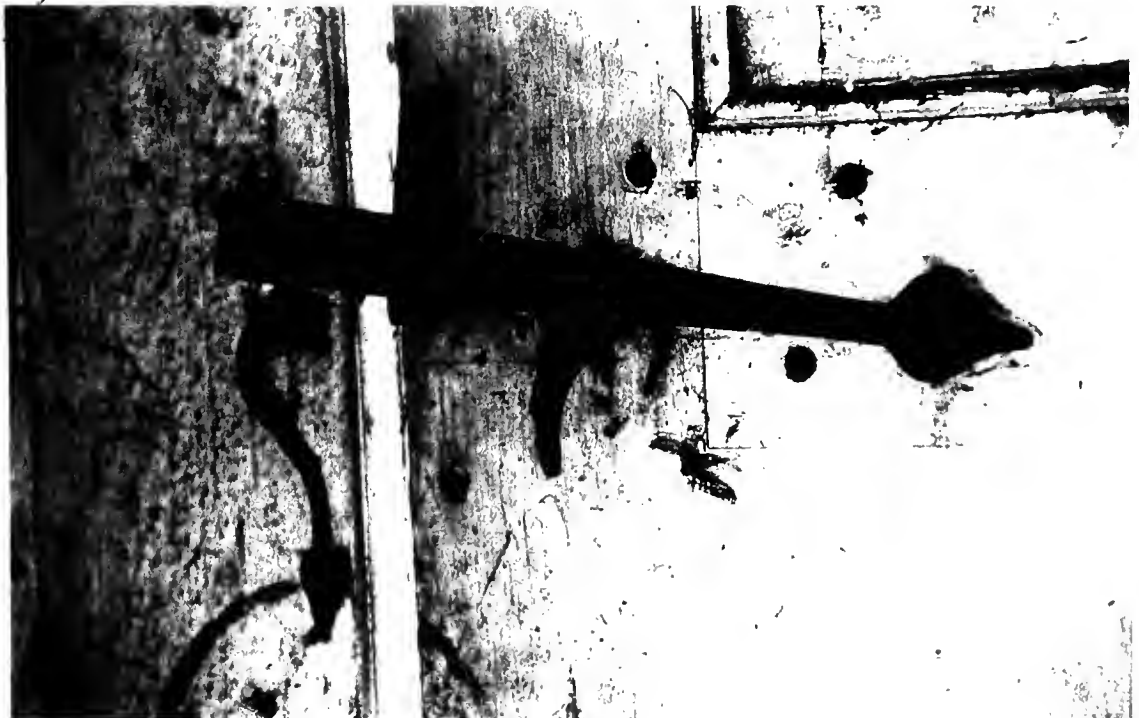
Figures 4.6c and 4.6d This is a hand wrought Suffolk latch with a dominant upper cusp. The interior view shows the wrought bar, staple and the catch (or keeper). The latch is decorated at the end, and the keeper is decorated in a similar motif and twisted.

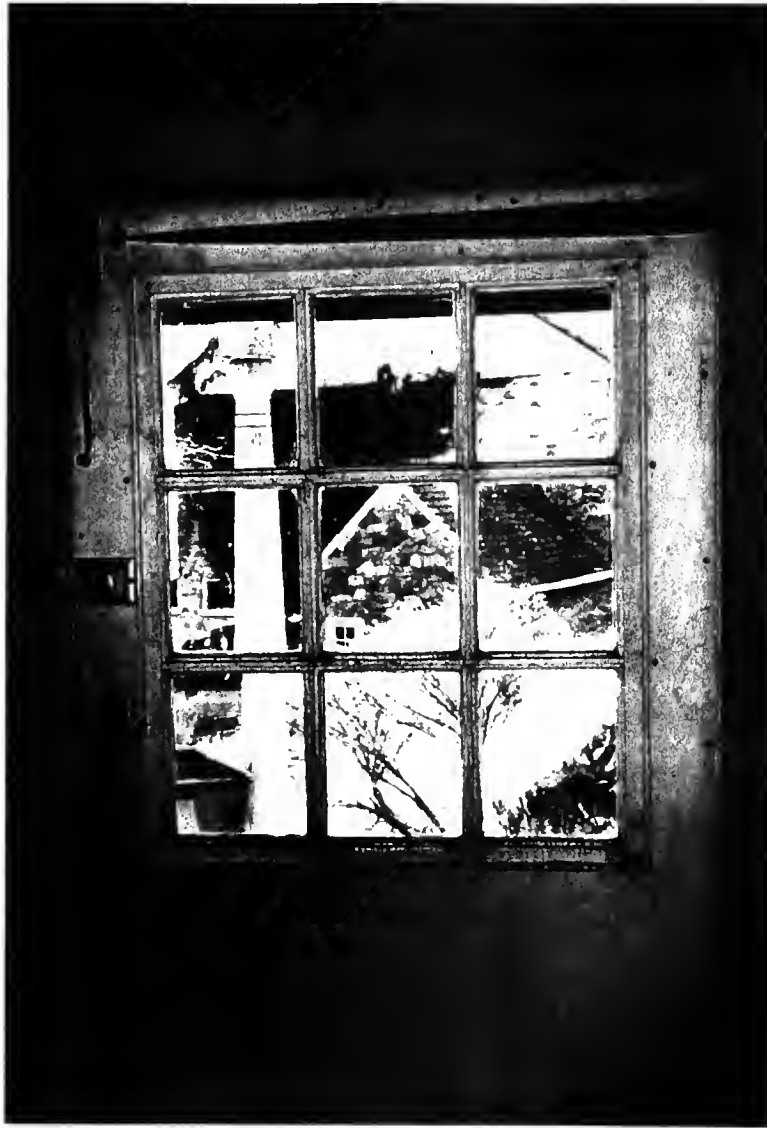
Figure 4.7 This is the door in the west hall leading to the west porch. This door incorporates many types of hardware including the typical strap hinge, a head bolt with a long, rounded handle and the keeper (similar to the one previously shown in the library).
